Manhole Inspection Summary

Manhole # **S15EE1030MH**

Insp Date: **6/20/07 10:59 AM**

Location Address: **2515 SHIRLEY AVE**

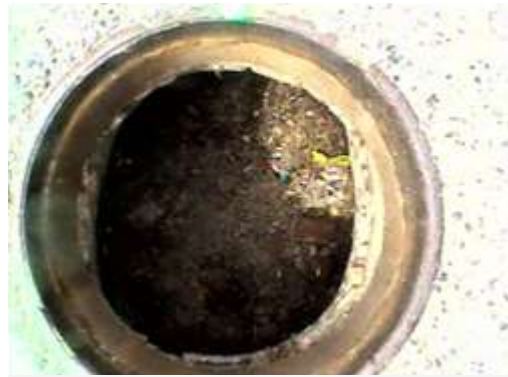
Top View

CHANNEL DEBRIS

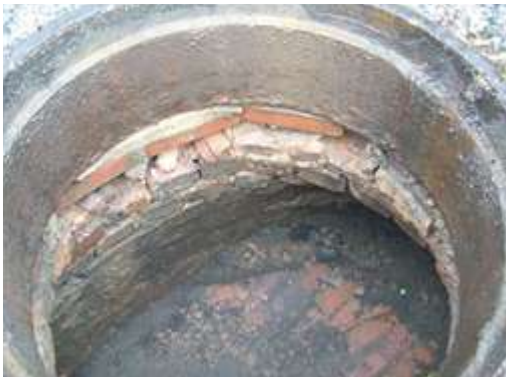
Defect 1

Condition: ☐ Sound ☒ **Cracked** ☐ Root Intrusion ☒ **Loose Brick** ☐ Deteriorated

CRACKED CORBEL AND LOOSE BRICKS

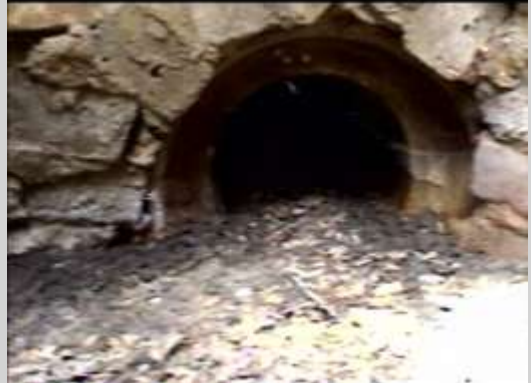
12 O'Clock Outflow

Deposits: ☐ None ☐ Mud ☐ Sludge ☒ **Debris** ☐ Grease

Silt Depth: **1** (in.) Deposits Extent: **Medium**

Infiltration: **None** Pipe Seal Cond: **Cracked**
